AN ANALYSIS OF CRITICALITY SAFETY « NEAR MISSES »

<u>Fabien DURET</u>, Matthieu DULUC, Johann HERTH (speaker)

THE 12TH INTERNATIONAL CONFERENCE ON NUCLEAR CRITICALITY SAFETY

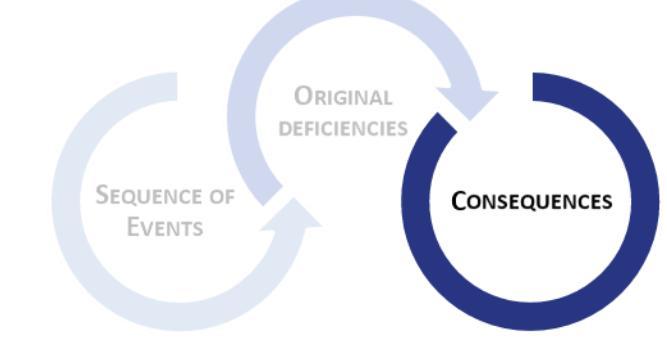
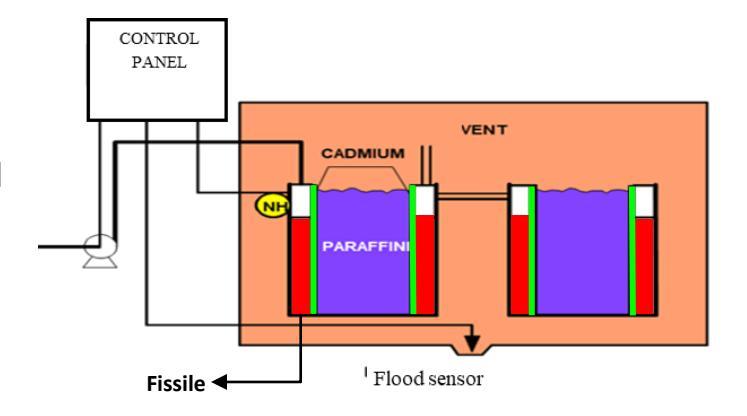
- Faulty Warning Light: did not signal the unintended transfer control.
- **Clogged Overflow:** machining chips in the tank clogged an overflow orifice.
- Vertical vent: caused internal overflow, toward the center of the tank.
- Cadmium Exposure: a bit of cadmium sticking out of the paraffin.

<u>Consequences</u>: type 3 ("Critical conditions potentially reached")

- Subcriticality was maintained thanks to the operational fissile concentration (10 g/L)
- But an accident could have occurred with the maximum authorized concentration (50 g/L), despite cadmium's absorbing effect.

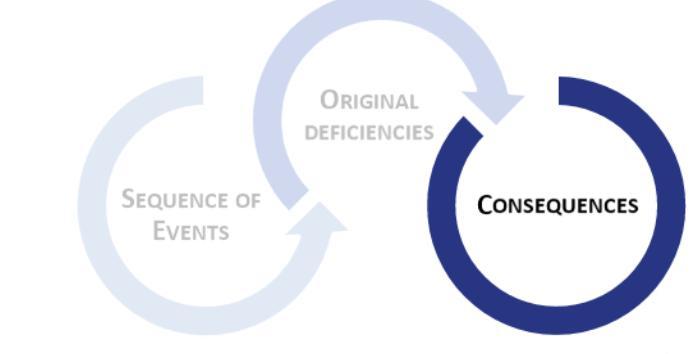
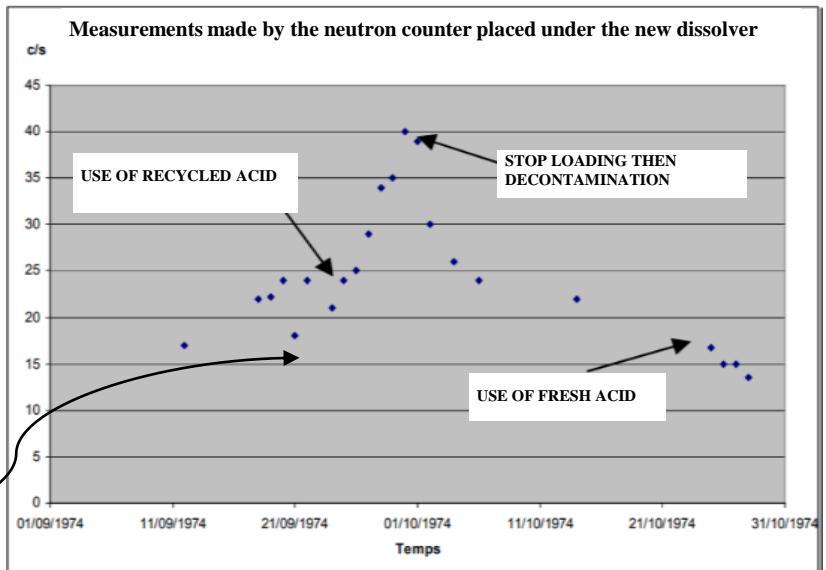
Consequences: type 1 ("critical conditions nearly reached"). Precipitates had resisted to acid rinses at the end of dissolution campaigns.

→ accumulation of 4.5 times the minimum critical mass of plutonium oxyfluoride (PuO_2F_2 with 13% ²⁴⁰Pu moderated and reflected by water, in an unsafe geometry).

Actions taken: after the event, multiple studies and tests have been set up to identify this phenomenon:

- Recover the precipitates (first basic rinses to "break" them, then boiling acid rinses...).
- Continue to use the large stock of recycled acid, but after forced precipitation with zirconium and filtration to "purify" it.
- Use a new dissolver equipped with a neutron counter to monitor the formation of precipitates.

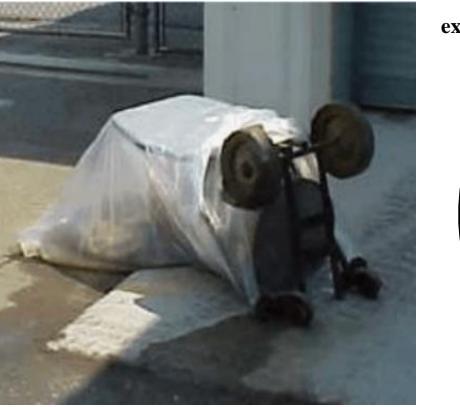
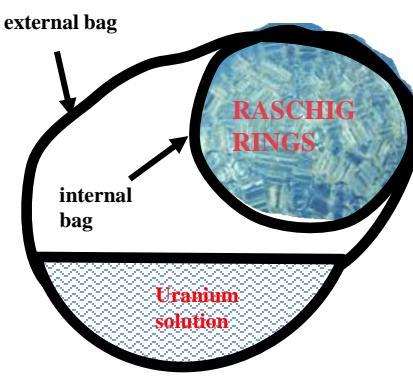
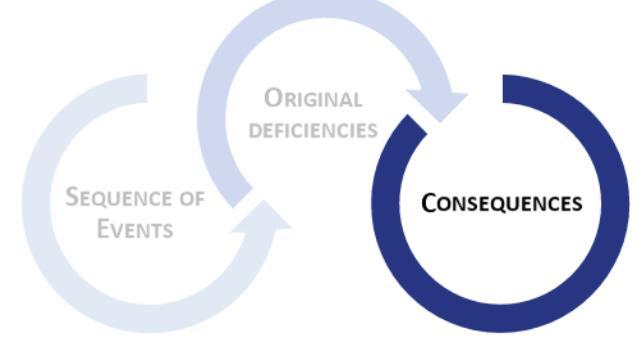
Original deficiency: type C ("discrepancy between the safety analysis and reality")

Handling conditions were not documented in the safety report and were not known by the criticality safety specialists

<u>Consequences: type 3 ("potential criticality")</u>

Subcriticality acquired because of low ²³⁵U concentration, but which could have been challenged under other authorized conditions (up to 32 L of solution at 400 g/L ²³⁵U)

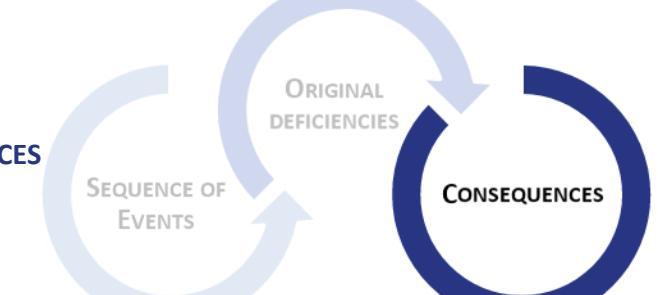
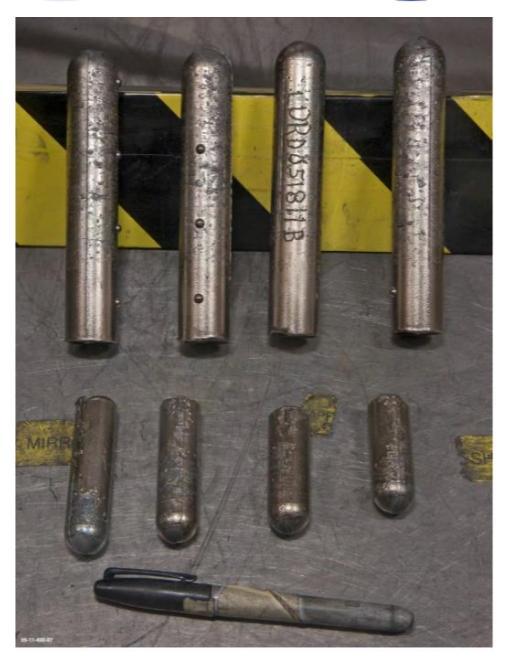
Consequences:

- Type 2 ("critical conditions remained away only thanks to a fast-human action") Without being stopped by the supervisor, operators might have grouped even more items, approaching critical conditions.
- **Type 4** ("strong impact on the operating conditions")
 - This event (and the context) caused an "exodus" of criticality safety engineers.
 - Plutonium processing operations halted for several years.

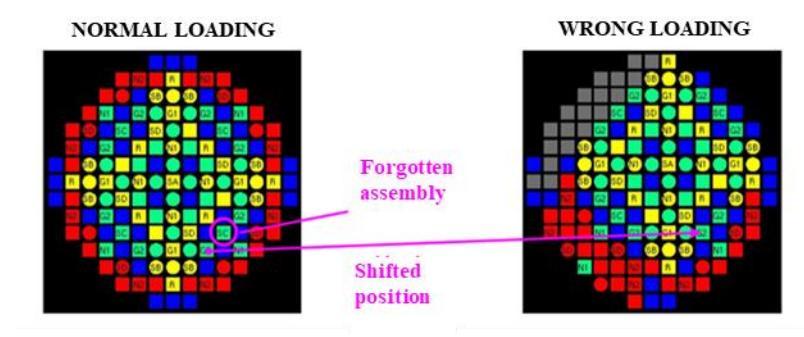
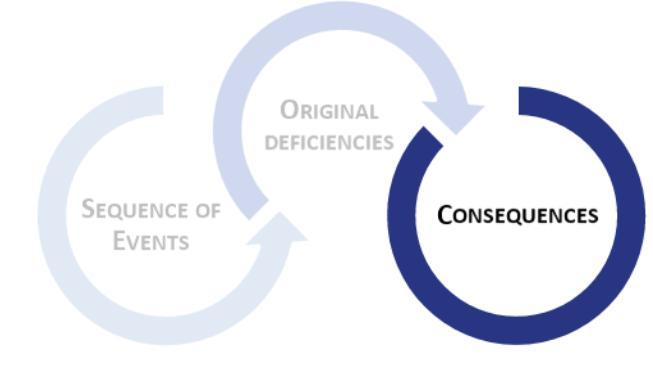
Original deficiency: type E ("forgetting the purpose of safety measures")

- The assembly's identification, crucial for the correct sequence, was only done in the spent fuel pool. The reactor team operated based on the sequence of assemblies, not their identification numbers.
- Some required controls had been skipped (matching of absorbing rods and assemblies in the reactor, transfer sheets in the in the spent fuel pool) → delayed detection

<u>Consequences</u>: type 3 ("potential criticality")

Under more penalizing conditions (minimum boron content, less irradiation), criticality could have been reached around 121 shifted assemblies (≅ 113).

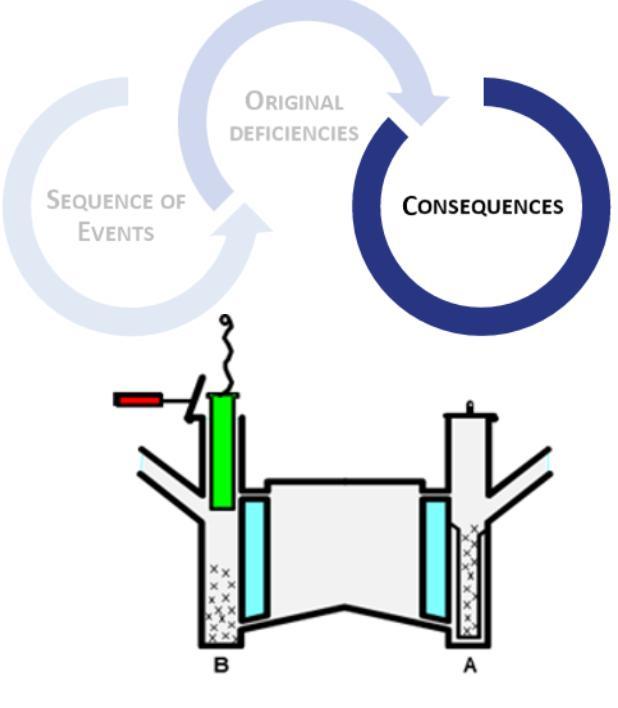
- **type E** ("forgetting the purpose of safety measures")
 - Original design: one clamp for basket handling and tube cap closing.
 → the event would not have occurred (can't close tube cap while clamp handles basket)
 - <u>Also a mechanical issue</u>: basket release signal based on air pressure, not clamp's actual state. Air pressure sufficient to activate signal, but not release basket, due to sealing defect.

Type 4 ("strong impact on operating conditions")

- Subcriticality would have been achieved thanks to the burn-up and dissolution speed, even potentially with the maximum authorized uranium enrichment.
- But it took 4 years to improve the clamp opening/closing signal system.

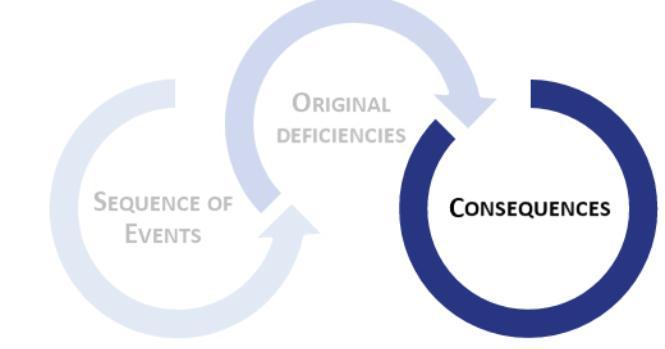
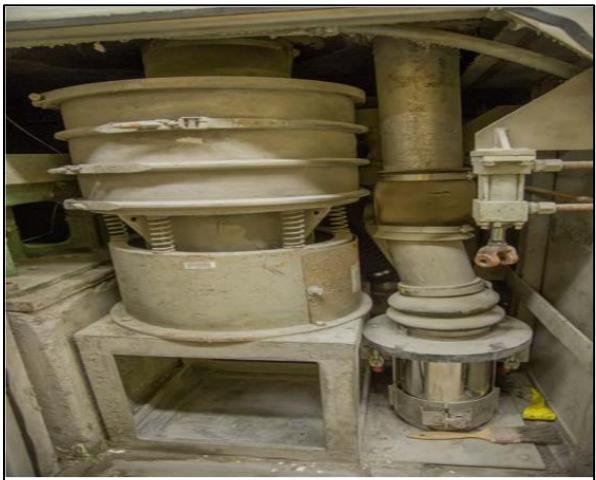
Fig. 1 Sand separator (left) and slag chute with can (rig

Progressive degradation of the calciothermal process

\rightarrow abnormal high quantities of uranium in the fluorite slag, making it difficult to grind it

ightarrow slag fragments overflowed from a receiver box and entered the chute

Type E ("forgetting the purpose of safety measures")

periodic emptying of the receiver box was foreseen in the design, but finally abandoned, since the quantity of fragments was negligible when calciothermy was functioning correctly.

Type 2 ("critical conditions remained away only thanks to a fast human action")

a worker cut off the water supply just in time (water was only mixed with a thin layer of sand)
