AN ANALYSIS OF CRITICALITY SAFETY « NEAR MISSES »

<u>Fabien DURET</u>, Matthieu DULUC, Johann HERTH (speaker)

THE 12TH INTERNATIONAL CONFERENCE ON NUCLEAR CRITICALITY SAFETY

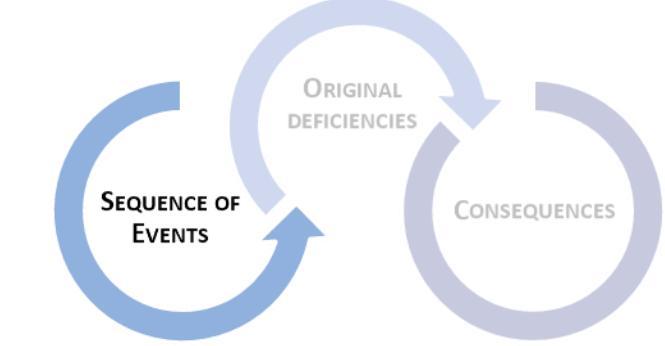
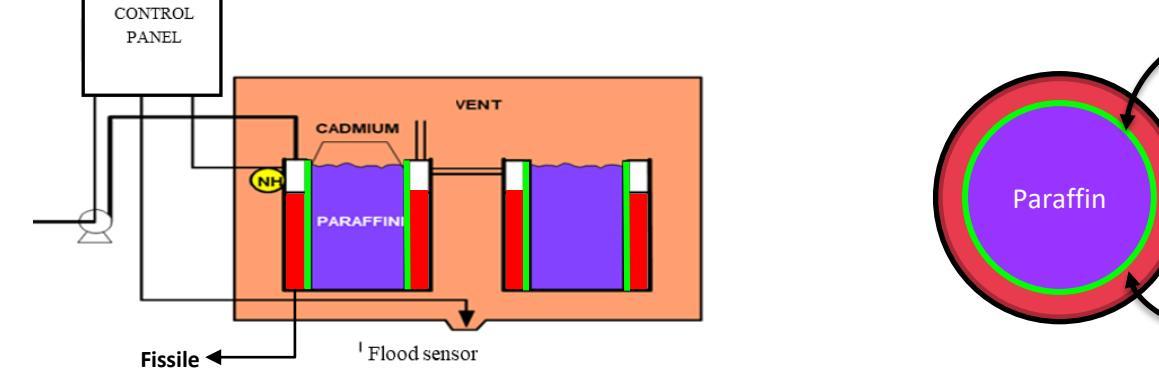
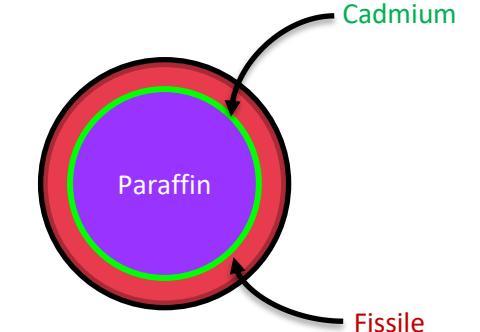
UNINTENDED TRANSFER OF A FISSILE SOLUTION TO AN ALREADY FULL ANNULAR TANK

- **Paraffin and Cadmium:** the tank's central cavity was filled with paraffin and coated with cadmium foil (neutron poison).
- Acid Overflowed: initiating corrosion of a small exposed cadmium part.
 - \rightarrow Heating melted the paraffin and release gas.

\rightarrow Paraffin transformed into foam, ejected from the tank, inhibiting a flood detector

\rightarrow The fissile solution filled the volume originally occupied by the paraffin.

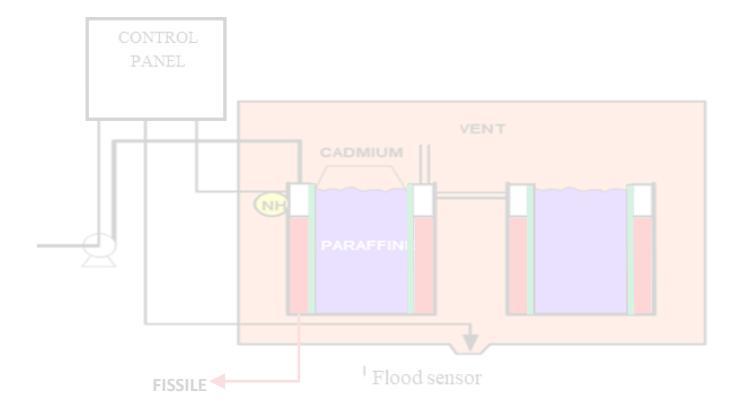
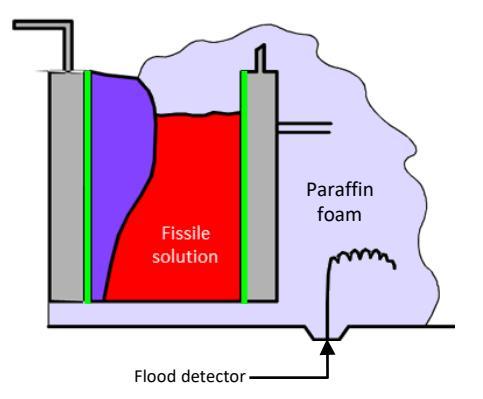
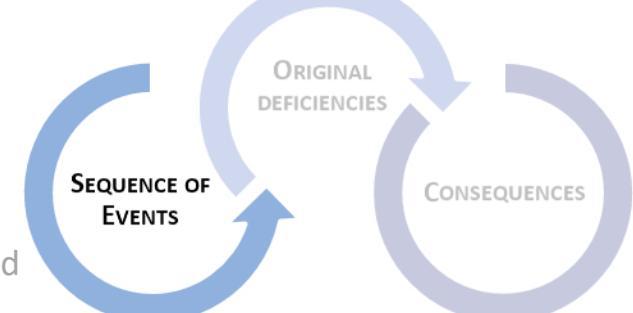
Original deficiency: type A, due to "several missed details"

- Faulty Warning Light: did not signal the unintended transfer control.
- **Clogged Overflow:** machining chips in the tank clogged an overflow orifice.
- Vertical vent: caused internal overflow, toward the center of the tank.
- Cadmium Exposure: a bit of cadmium was sticking out of the paraffin.

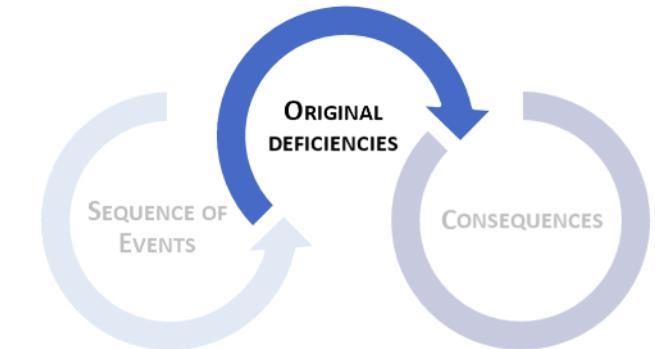
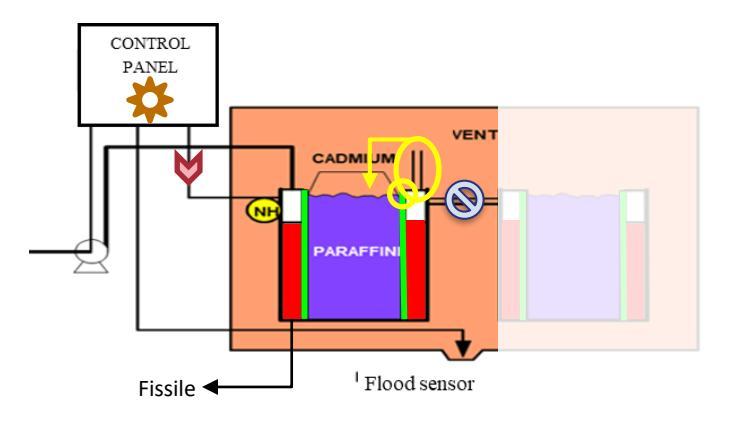
Original deficiency: type A, due to "several missed details"

- Faulty Warning Light: did not signal the unintended transfer control.
- **Clogged Overflow:** machining chips in the tank clogged an overflow orifice.
- Vertical vent: caused internal overflow, toward the center of the tank.
- Cadmium Exposure: a bit of cadmium sticking out of the paraffin.

<u>Consequences</u>: type 3 ("Critical conditions potentially reached")

- Subcriticality was maintained thanks to the operational fissile concentration (10 g/L)
- But an accident could have occurred with the maximum authorized concentration (50 g/L), despite cadmium's absorbing effect.

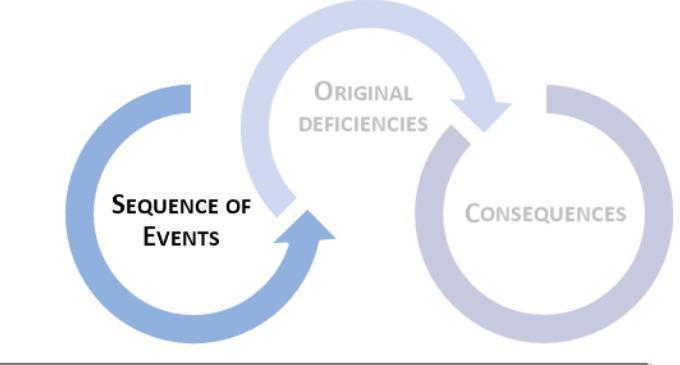
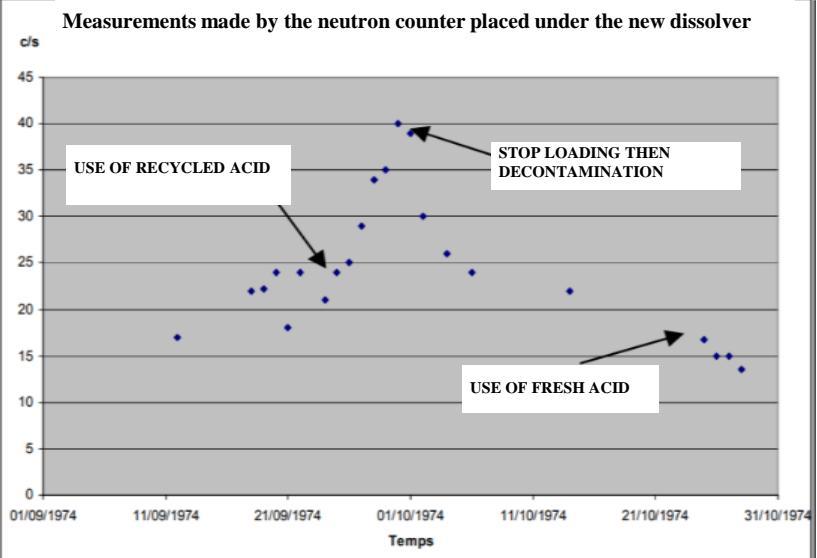
PLUTONIUM SLOW ACCUMULATION IN A URANIUM-GRAPHITE-GAS FUEL DISSOLVER

- Context: abnormal accumulation of Pu in a dissolver for natural uranium-graphite-gas reactor assemblies.
- **Detection**: unusually high temperature.
- Implication: accumulation of fission products.

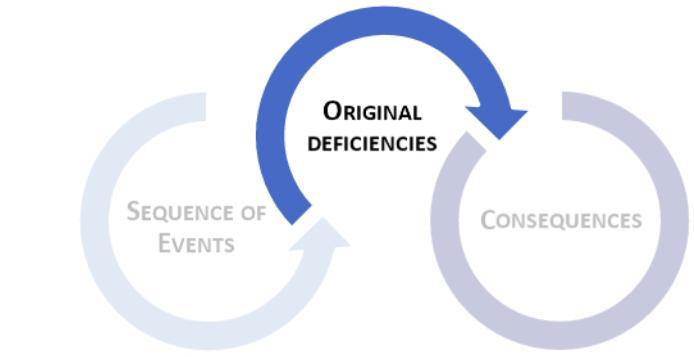
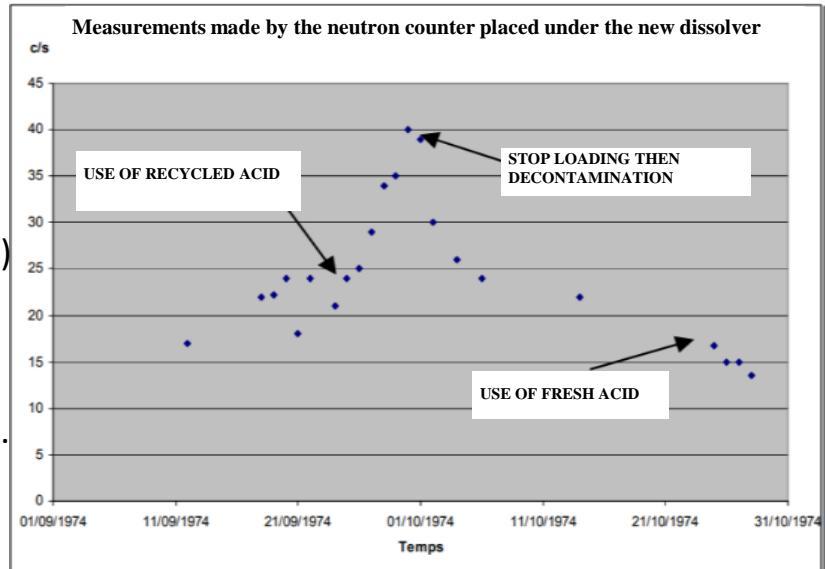
Original deficiency: Type B ("unknown physical phenomenon")

- Phenomenon: Pu had been adsorbed on precipitates of zirconium phosphates (fission product).
- Cause: Use of recycled acid and water containing tributyl phosphate (TBP) or its degradation products in the dissolver.

Consequences: type 1 ("critical conditions nearly reached"). Precipitates had resisted to acid rinses at the end of dissolution campaigns.

→ accumulation of 4.5 times the minimum critical mass of plutonium oxyfluoride (PuO_2F_2 with 13% ²⁴⁰Pu moderated and reflected by water, in an unsafe geometry).

Actions taken: after the event, multiple studies and tests have been set up to identify this phenomenon:

- Recover the precipitates (first basic rinses to "break" them, then boiling acid rinses...).
- Continue to use the large stock of recycled acid, but after forced precipitation with zirconium and filtration to "purify" it.
- Use a new dissolver equipped with a neutron counter to monitor the formation of precipitates.

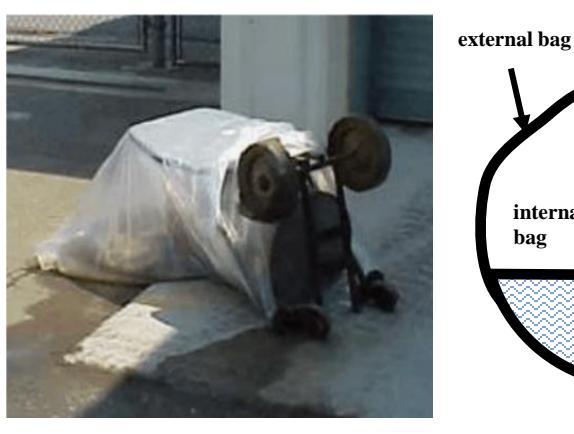
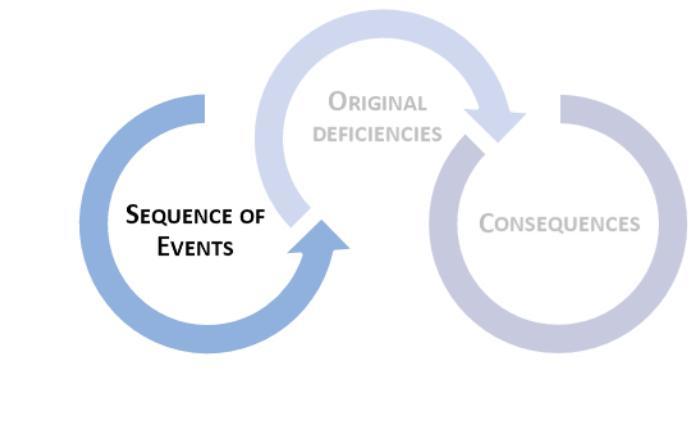
FALL OF A VACUUM CLEANER FILLED WITH RASCHIG RINGS (BOROSILICATE GLASS) AND URANIUM SOLUTION

The vacuum cleaner was packed in two plastic bags and placed on a forklift without proper lifting attachments.

- During a transfer, the vacuum cleaner fell off the forklift when it climbed an access ramp:
 - The fissile solution leaked into the outer bag in an unsafe geometry.
 - The Raschig rings partially spilled out of the vacuum cleaner but remained within the inner bag.

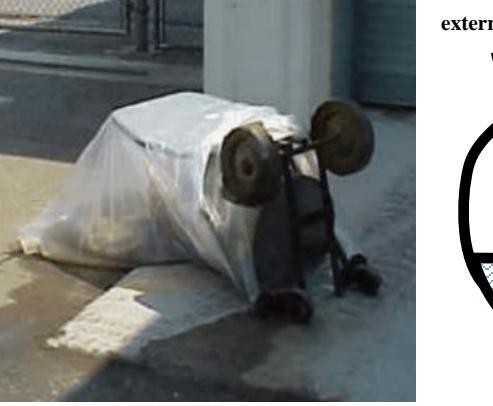
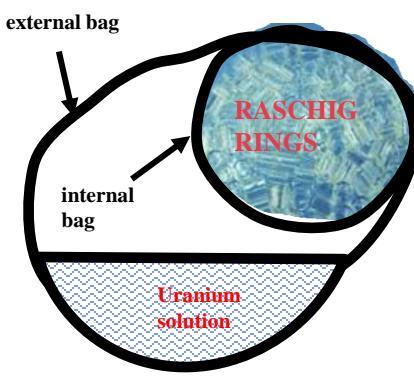
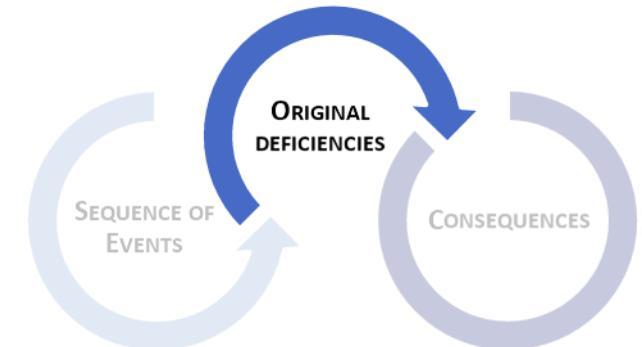
Original deficiency: type C ("discrepancy between the safety analysis and reality")

Handling conditions were not documented in the safety report and were not known by the criticality safety specialists.

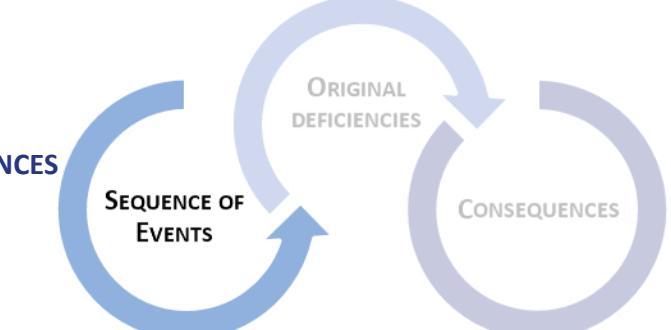
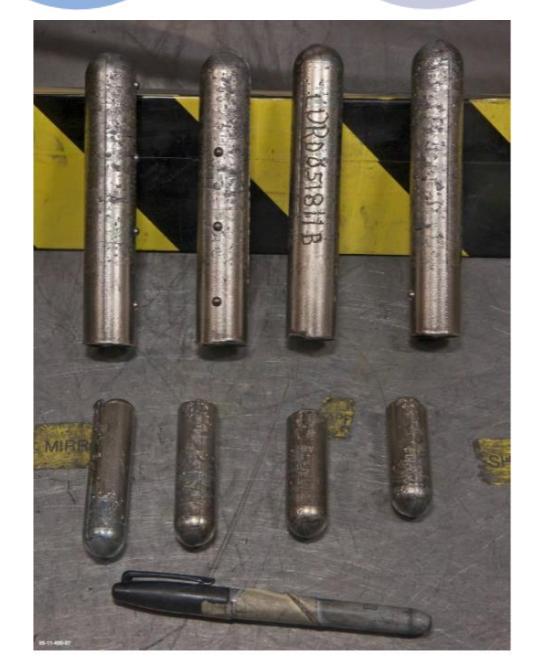
GATHERING OF FISSILE METALLIC OBJECTS NORMALLY SEPARATED BY MINIMAL DISTANCES

- To take a photograph, technicians gathered 8 metallic Pu rods (normally separated by minimal distances).
- In addition, a supervisor asked the workers to separate the parts immediately, instead of taking the usual precaution.

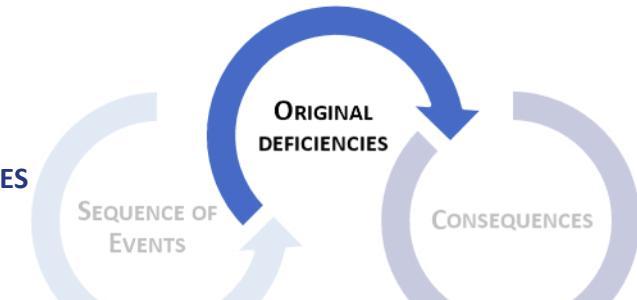
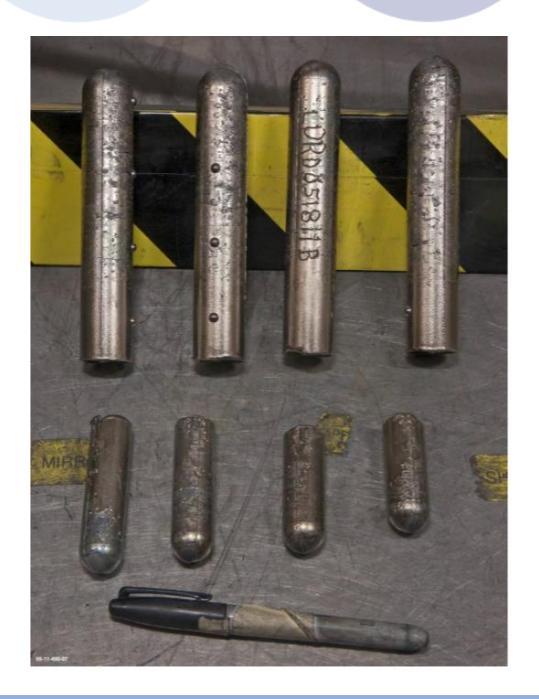
<u>Original deficiency</u>: type D ("lack of criticality safety training")

- "Desensitization": staff was unaware of the criticality risk.
- Context: precursory anomalies and tensions between criticality safety teams and management led to shortcomings in oversight and operational guidance.

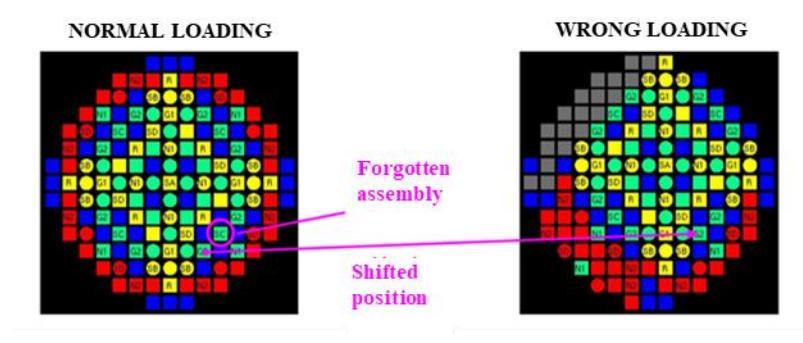
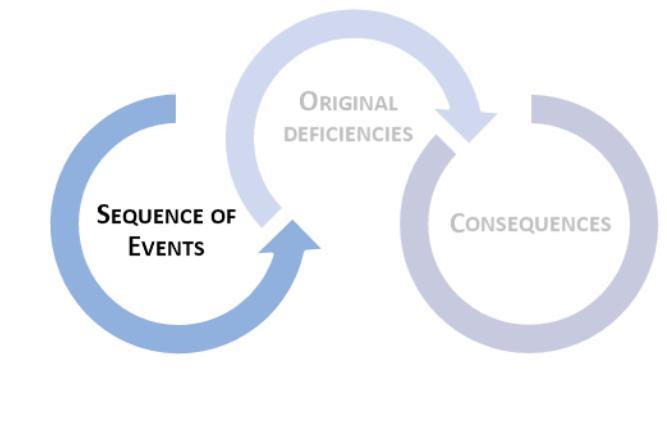
SHIFT IN THE POSITION OF **113** CONSECUTIVE ASSEMBLIES IN THE CORE OF THE REACTOR BUILDING

- Following a change of roles of workers in the fuel storage building, one assembly was mistakenly left in the pool, because its transfer sheet had been filled before the real transfer (to save time).
- This led to the shift of the next 113 assemblies in the reactor core.

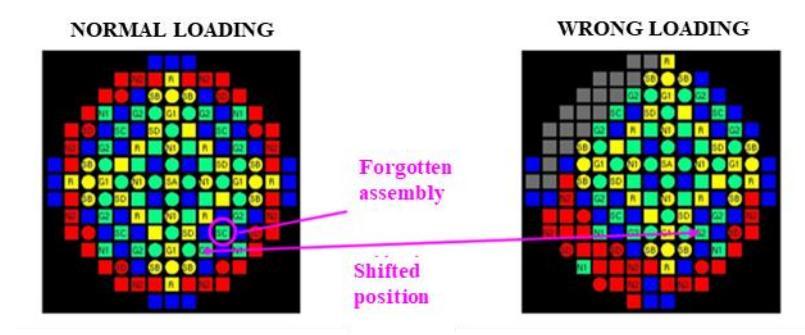
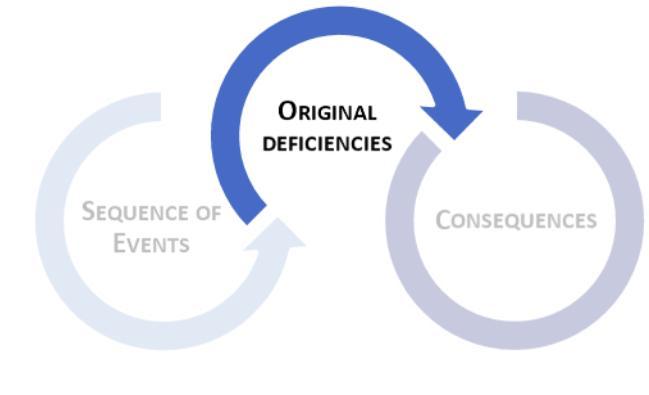
Original deficiency: type E ("forgetting the purpose of safety measures")

- The assembly's identification, crucial for the correct sequence, was only done in the spent fuel pool. The reactor team operated based on the sequence of assemblies, not their identification numbers.
- Some required controls had been skipped (matching of absorbing rods and assemblies in the reactor, transfer sheets in the spent fuel pool) → delayed detection

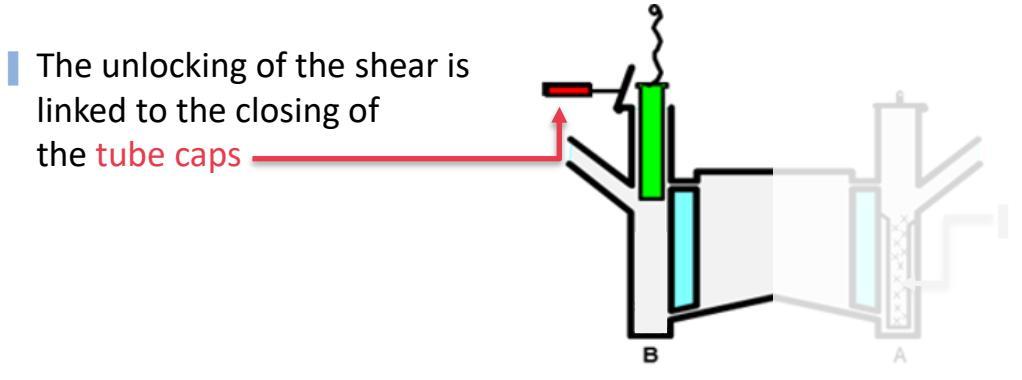
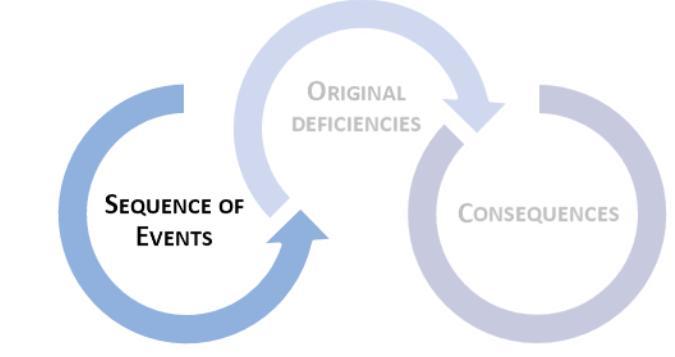
SHEARED PIECES OF FUEL ASSEMBLIES DISSOLVED IN A TUBE OF UNSAFE GEOMETRY

In normal conditions, sheared pieces of fuel assemblies were put in a basket of safe geometry and then dissolved

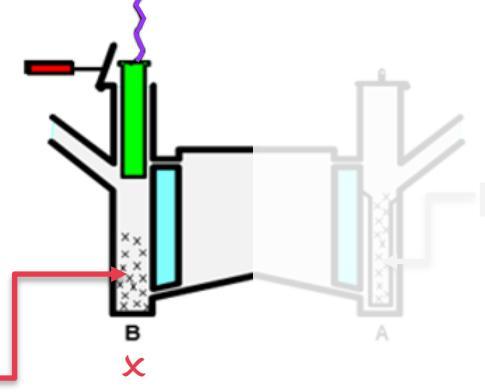
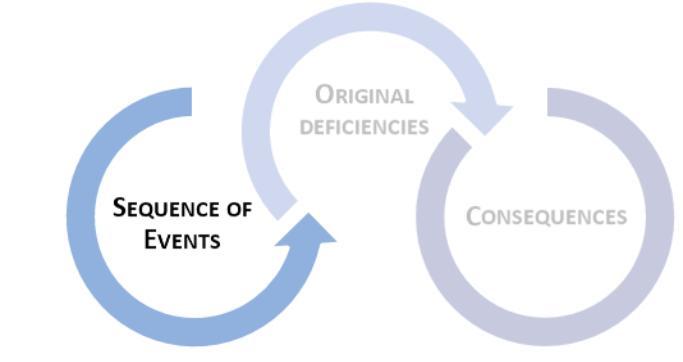
The unlocking of the shear is linked to the closing of the tube caps

The basket had remained hooked to the handling clamp \rightarrow The pieces of an assembly were dissolved directly in the tube of unsafe geometry

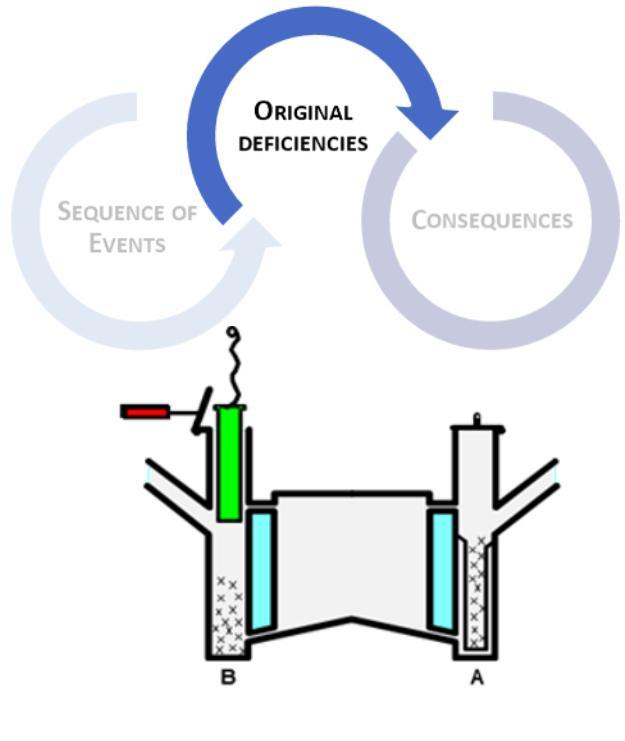
type E ("forgetting the purpose of safety measures")

- Original design: one clamp for basket handling and tube cap closing.
 → the event would not have occurred (can't close tube cap while clamp handles basket)
- <u>Also a mechanical issue</u>: basket release signal based on air pressure, not clamp's actual state. Air pressure sufficient to activate signal, but not to release basket, due to sealing defect.

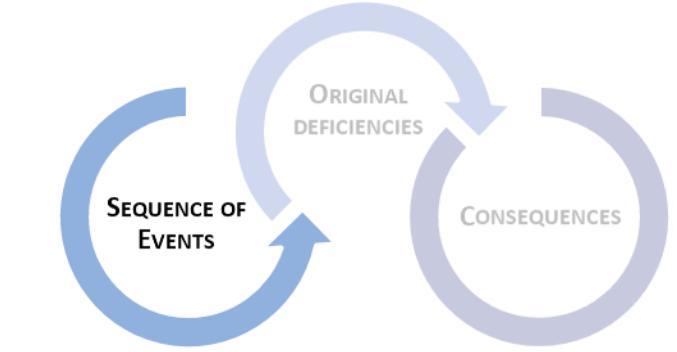
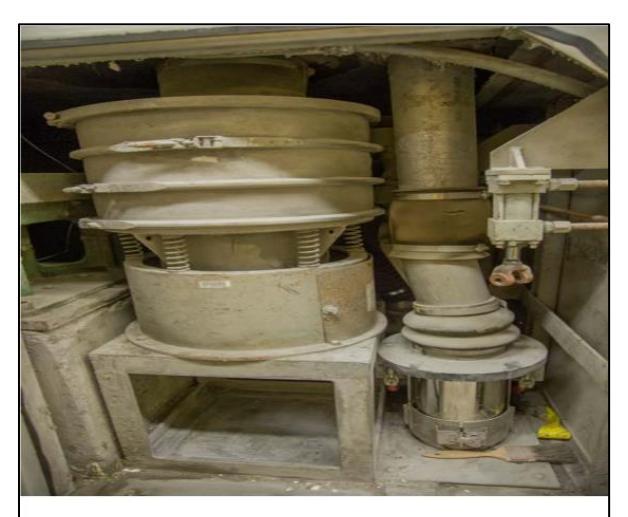
Fig. 1 Sand separator (left) and slag chute with can (rig

WATER LEAK NEAR A SLAG CHUTE OF UNSAFE GEOMETRY CONTAINING AN UNSUSPECTED MASS OF URANIUM (UNCONTROLLED ACCUMULATION)

Progressive degradation of the calciothermal process: → abnormal high quantities of uranium in the fluorite slag, making it difficult to grind it.

\rightarrow slag fragments overflowed from a receiver box and entered the chute.

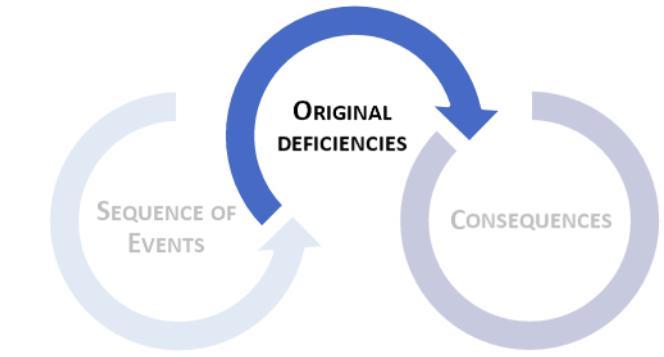
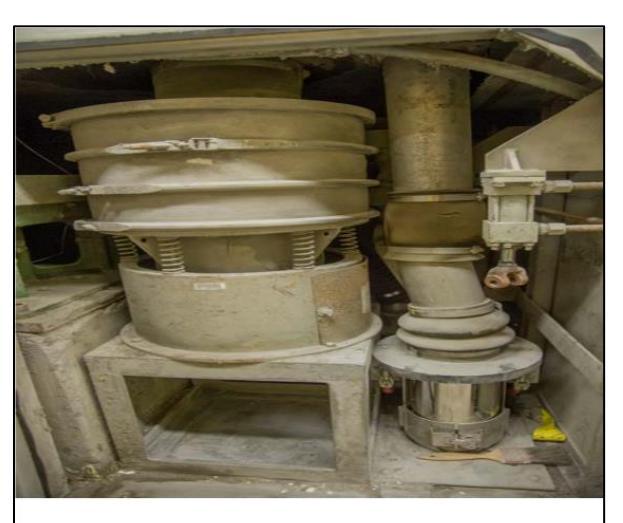
Fig. 1 Sand separator (left) and slag chute with can (rig

type E ("forgetting the purpose of safety measures")

periodic emptying of the receiver box was foreseen in the design, but finally abandoned, since the quantity of fragments was negligible when calciothermy was functioning correctly.
